## **Craiginmoddie Wind Farm**

**Peat Stability Risk Assessment**  
December 2022

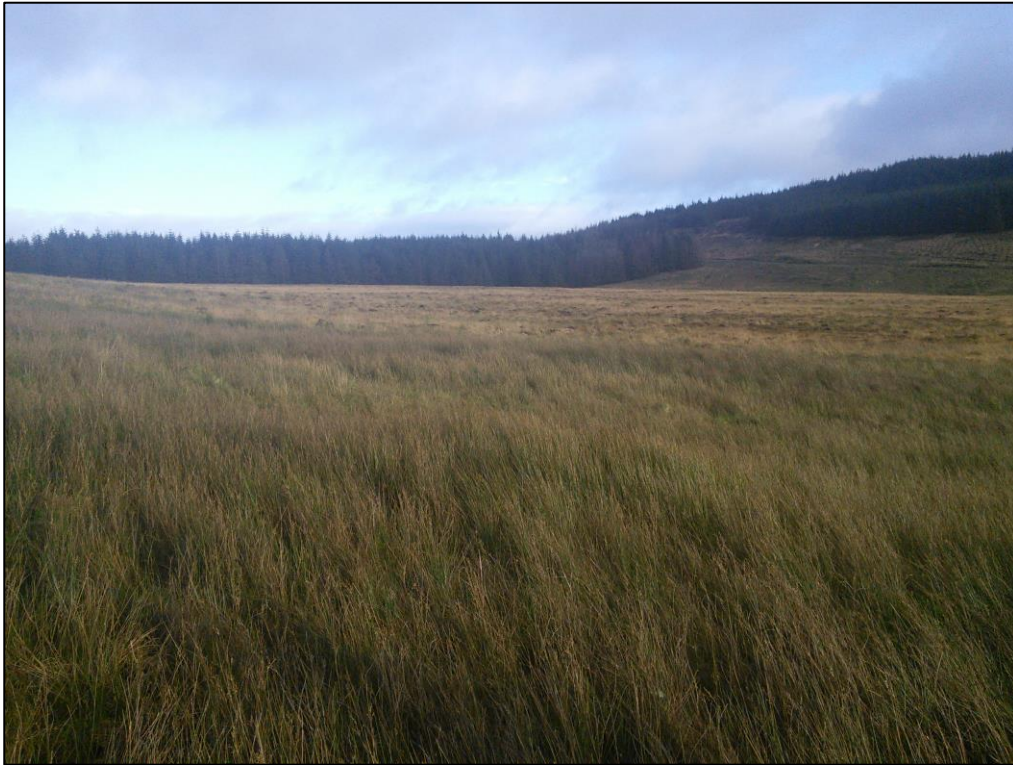
**Photo 1: View north from T8 – Open Ground, recently planted**

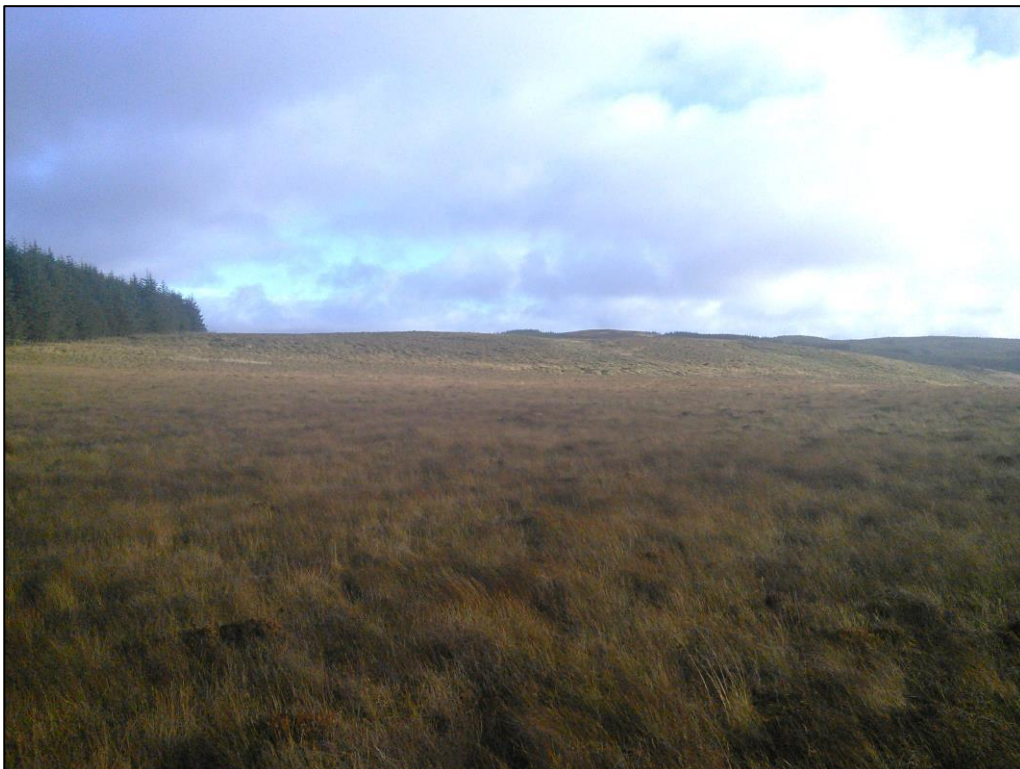
**Photo 2: View north from T9 – Open Ground Raised Bog**

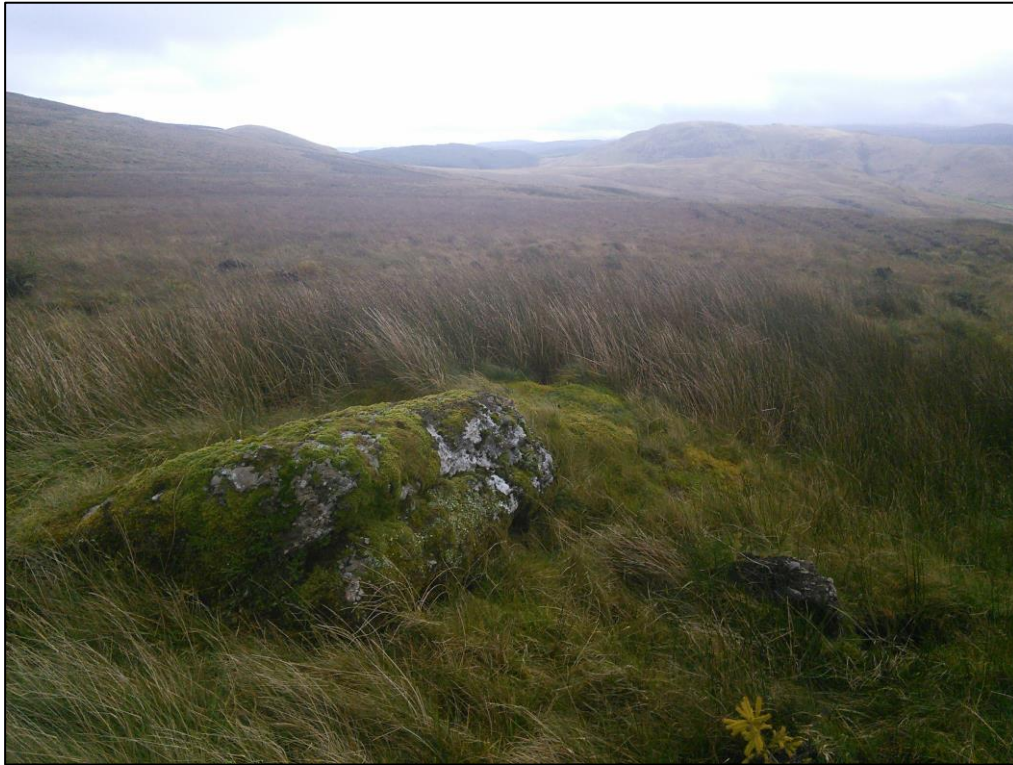
**Photo 3: Borrow Pit Search Area south from T6**
