# Craiginmoddie Wind Farm

## Technical Appendix 12.1: Watercourse Crossing Assessment

## Technical Appendix 12.2: Peat Management Plan

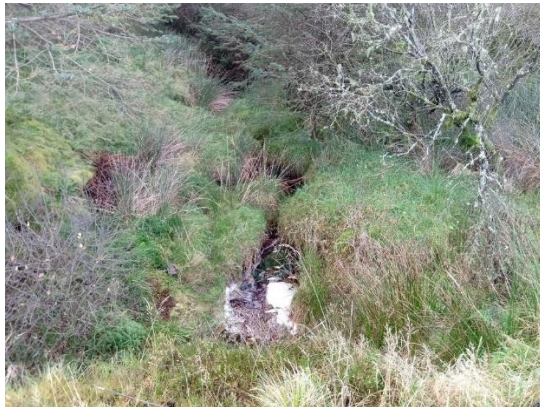
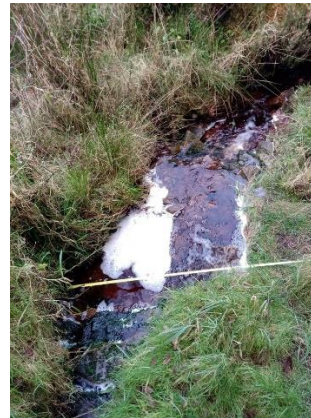
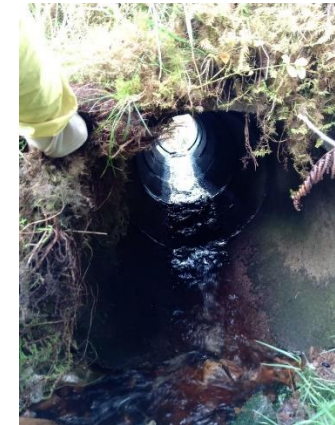
## WC 1 (231494, 599662)

- **Existing Crossing:** Yes
- **Crossing Type (existing):** Circular Culvert
- **Crossing Material (existing):** Concrete
- **Crossing Condition (existing):** Good
- **Channel Type:** Meandering
- **Gradient:** Steep
- **Valley form:** Deep vee
- **Bank condition:** Undercut (no evidence of recent collapse)
- **Bed material:** Fine sand/silt, Coarse gravel, Boulders, Bedrock
- **Riparian corridor:** Commercial Forestry
- **Flow condition:** Fast

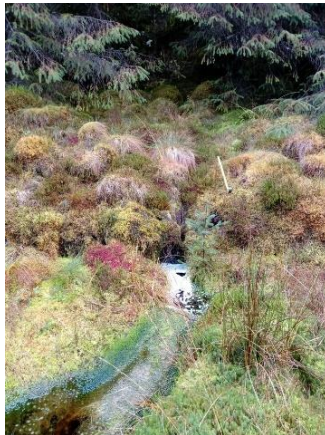
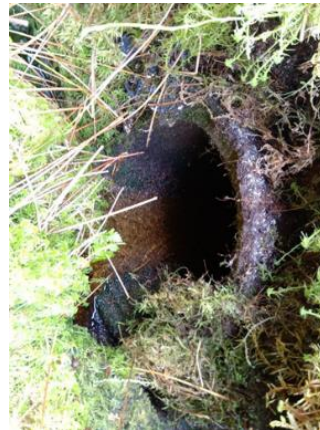
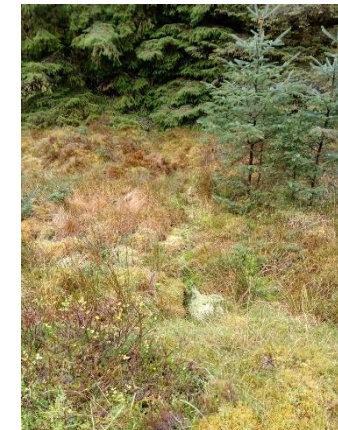
## WC 2 (231044, 598947)

- **Existing Crossing:** Yes
- **Crossing Type (existing):** Circular Culvert
- **Crossing Material (existing):** Concrete
- **Crossing Condition (existing):** Average
- **Channel Type:** Incised
- **Gradient:** Gentle
- **Valley form:** No obvious valley sides
- **Bank condition:** Stable
- **Bed material:** Vegetation, Soil, Peat
- **Riparian corridor:** Commercial Forestry
- **Flow condition:** Very slow
- **Culvert Dimensions (m):** 0.45 diameter
- **Water width (m):** 0.2 to 1.1
- **Water depth (m):** 0.62 (immediately upstream of culvert)
- **Bankfull width (m):** 1.25
- **Bankfull height (m):** 0.65
- **Banktop height (m):** 0.9
- **Flooded Bankfull width (m):** 1.6
- **Flooded Bankfull height:** 0.7

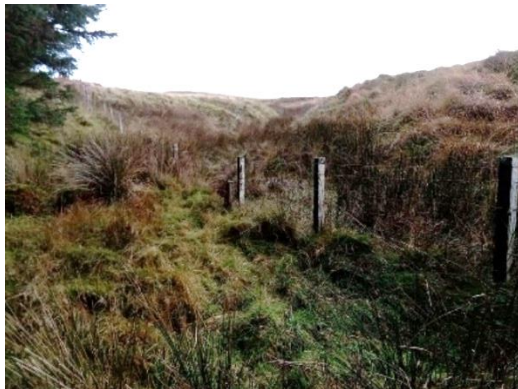
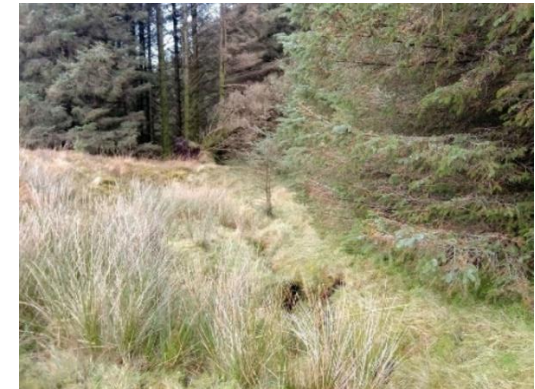
## WC 3 (230425, 598600)

- **Existing Crossing:** No
  - **Crossing Type (Recommended):** Circular Culvert
  - **Channel Type:** Incised and Surface run-off/wetlands only
  - **Gradient:** Steep

- **Valley form:** Shallow vee
  - **Bank condition:** Unstable (potential recent collapse)
  - **Bed material:** Fine sand/silt, Coarse gravel, Rounded pebbles, Vegetation

- **Riparian corridor:** Moorland, Commercial Forestry
  - **Flow condition:** Moderate
  - **Water width (m):** 0.4 (0.2 immediately upstream)
  - **Water depth (m):** 0.04 to 0.06

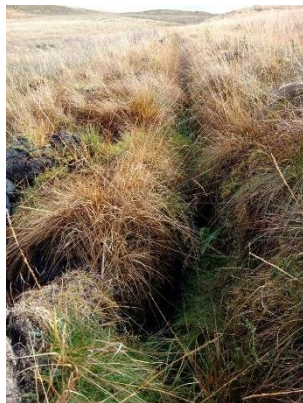
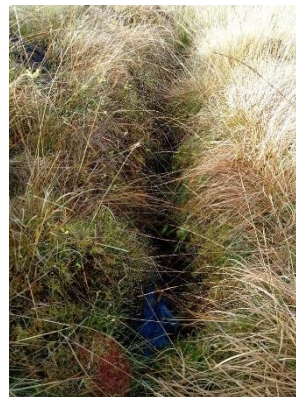
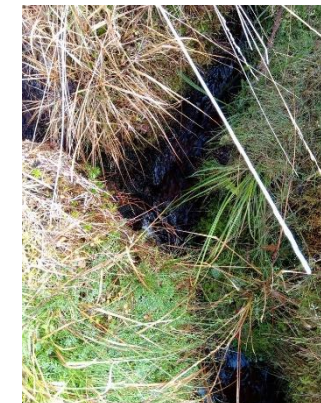
## WC 4 (231866, 598670)

- **Existing Crossing:** No
- **Crossing Type (Recommended):** Circular Culvert
- **Channel Type:** Artificial drainage channel
- **Gradient:** Moderate
- **Valley form:** Deep vee
- **Bank condition:** Stable
- **Bed material:** Peat
- **Riparian corridor:** Moorland
- **Flow condition:** Moderate

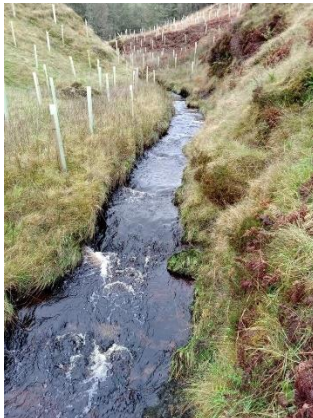
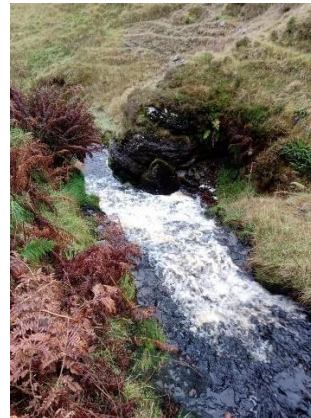
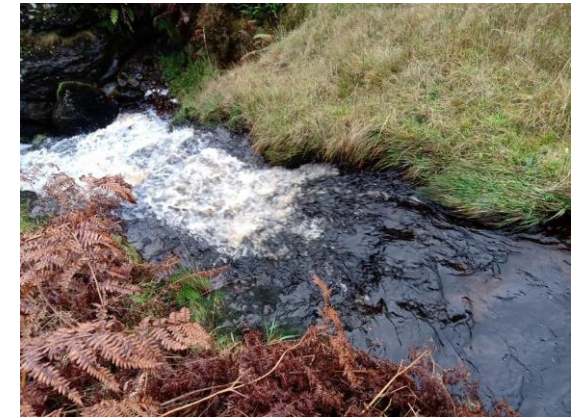
## WC 5 (231526, 598380)

- **Existing Crossing:** No
- **Crossing Type (Recommended):** Bridge (no in-channel support)
- **Channel Type:** Incised
- **Gradient:** Steep
- **Valley form:** Deep vee
- **Bank condition:** Stable
- **Bed material:** Coarse gravel, Rounded pebbles, Boulders
- **Riparian corridor:** Moorland, Commercial Forestry
- **Flow condition:** Moderate
- **Water width (m):** 1.29
- **Water depth (m):** 0.2
- **Bankfull width (m):** 2
- **Bankfull height (m):** 0.6
- **Banktop height (m):** N/A
- **Flooded Bankfull width (m):** 5
- **Flooded Bankfull height:** 0.8

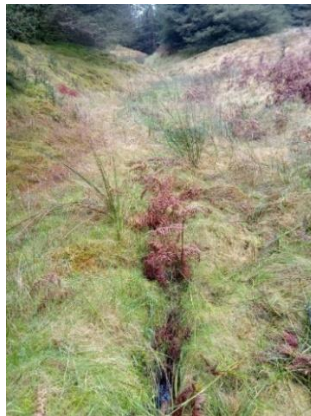
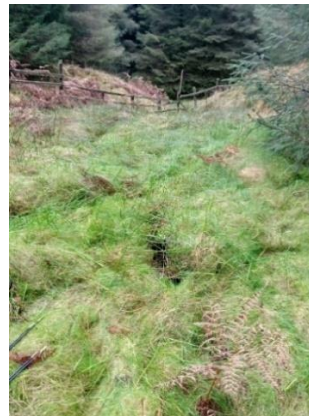
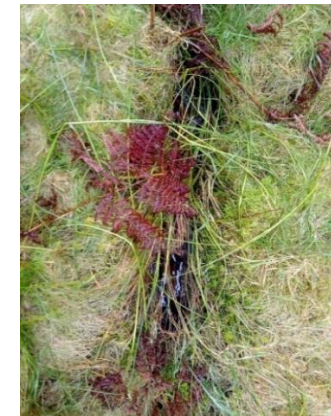
## WC 6 (231269, 598410)

- **Existing Crossing:** No
- **Crossing Type (Recommended):** Circular Culvert
- **Channel Type:** Incised
- **Gradient:** Steep
- **Valley form:** Deep vee
- **Bank condition:** Stable
- **Bed material:** Vegetation
- **Riparian corridor:** Commercial Forestry
- **Flow condition:** Very slow

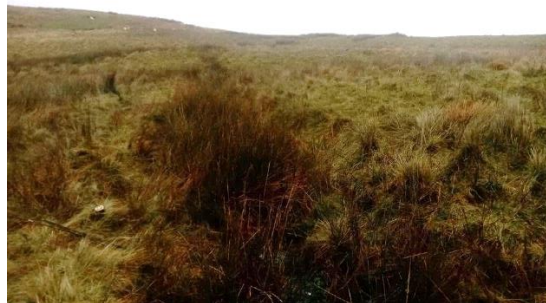
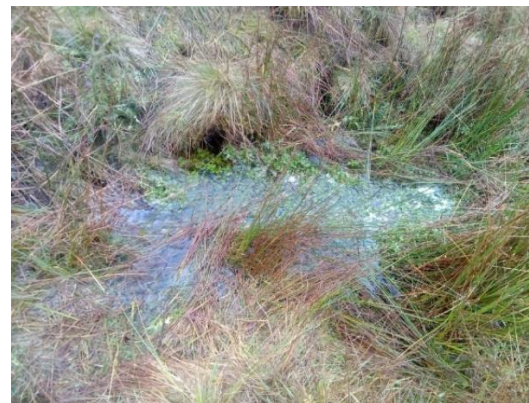
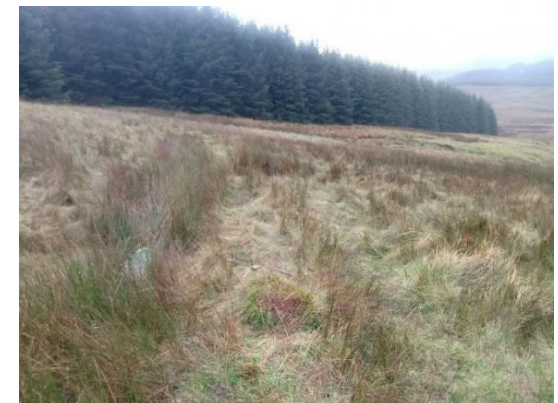
## WC 7 (230493, 598127)

- **Existing Crossing:** No
  - **Crossing Type (Recommended):** Circular Culvert
  - **Channel Type:** Incised, Artificially modified watercourse, Artificial drainage channel
  - **Gradient:** Moderate
  - **Valley form:** No obvious valley sides
  - **Bank condition:** Stable
  - **Bed material:** Vegetation, Peat
  - **Riparian corridor:** Moorland, Agricultural Grazing
  - **Flow condition:** Moderate
- **Water width (m):** 0.9
  - **Water depth (m):** 0.12 to 0.16
  - **Bankfull width (m):** 1.3
  - **Bankfull height (m):** 0.3
  - **Banktop height (m):** 0.35
  - **Flooded Bankfull width (m):** 1.9
  - **Flooded Bankfull height:** 0.4

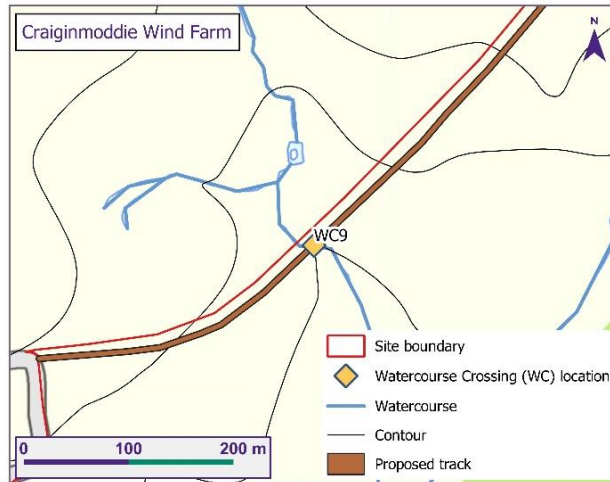
## WC 9 (229679, 597825)

- **Existing Crossing:** No
  - **Crossing Type (Recommended):** Circular Culvert
  - **Channel Type:** Incised, Meandering
  - **Gradient:** Gentle
  - **Valley form:** Shallow vee
  - **Bank condition:** Undercut (no evidence of recent collapse)
  - **Bed material:** Vegetation, Soil, Peat
  - **Riparian corridor:** Moorland
  - **Flow condition:** Moderate
- **Water width (m):** 0.35 to 0.6
  - **Water depth (m):** 0.36
  - **Bankfull width (m):** 0.65
  - **Bankfull height (m):** 0.4 (approx.)
  - **Banktop height (m):** 1.2
  - **Flooded Bankfull width (m):** 1.4
  - **Flooded Bankfull height:** 0.45 (approx.)
- Note:** Registration.

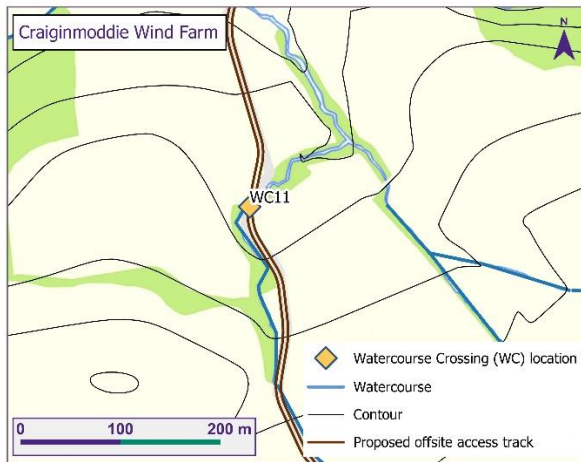
## WC 11 (227509, 600635)

- **Existing Crossing:** Yes
- **Crossing Type (existing):** Circular Culvert
- **Crossing Material (existing):** Concrete
- **Crossing Condition (existing):** Average
- **Channel Type:** Broad
- **Gradient:** Gentle
- **Valley form:** U-shape valley
- **Bank condition:** Undercut (no evidence of recent collapse)
- **Bed material:** Fine sand/silt, Rounded pebbles, Coarse gravel, Boulders
- **Riparian corridor:** Heavily Vegetated (e.g. gorse, bramble)
- **Flow condition:** Moderate

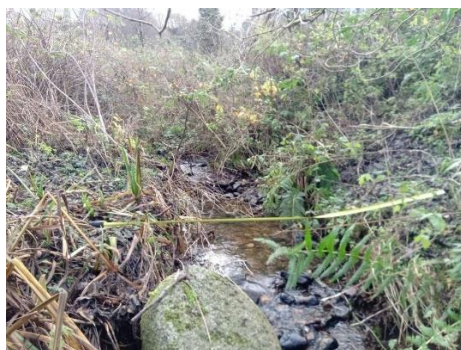
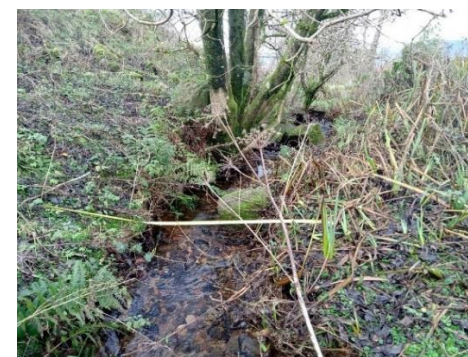
## WC 12 (227633, 600306)

- **Existing Crossing:** No
- **Crossing Type (Recommended):** Bottomless Arch Culvert
- **Channel Type:** Broad
- **Gradient:** Gentle
- **Valley form:** U-shape valley
- **Bank condition:** Stable
- **Bed material:** Fine sand/silt, Rounded pebbles, Coarse gravel, Boulders
- **Riparian corridor:** Heavily Vegetated (e.g. gorse, bramble)
- **Flow condition:** Moderate

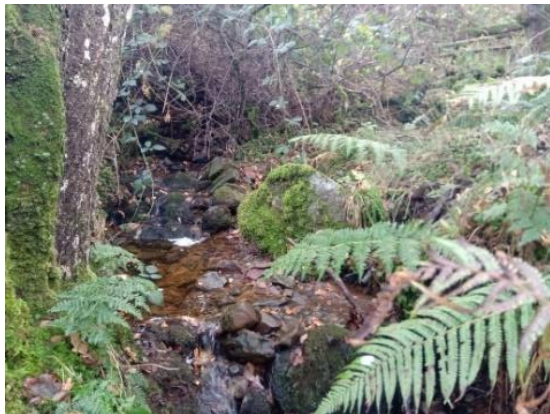
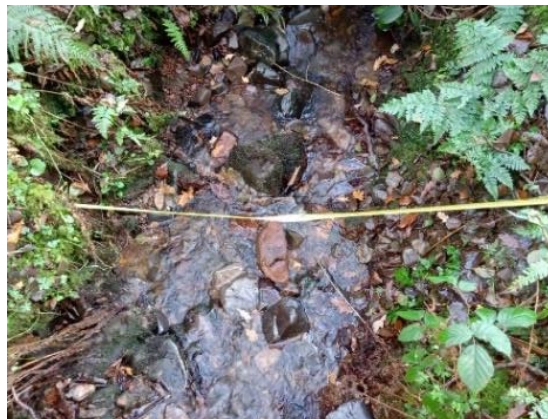
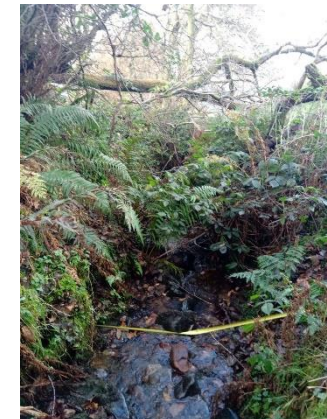
## WC 13 (227896, 600339)

- **Existing Crossing:** No
- **Crossing Type (Recommended):** Bridge (no in-channel support)
- **Channel Type:** Incised
- **Gradient:** Moderate
- **Valley form:** Deep vee
- **Bank condition:** Undercut (no evidence of recent collapse)
- **Bed material:** Rounded pebbles, Fine sand/silt, Coarse gravel, Boulders
- **Riparian corridor:** Heavily Vegetated (e.g. gorse, bramble)
- **Flow condition:** Moderate

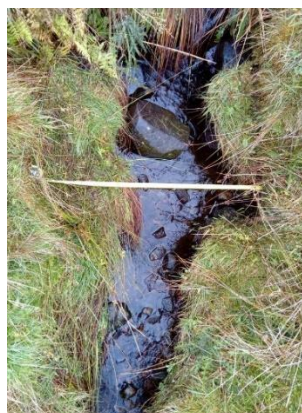
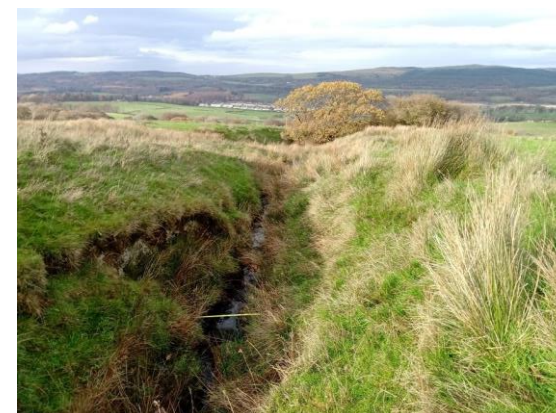
## WC 14 (228077, 600343)

- **Existing Crossing:** No
- **Crossing Type (Recommended):** Bottomless Arch Culvert
- **Channel Type:** Incised
- **Gradient:** Moderate
- **Valley form:** Shallow vee
- **Bank condition:** Undercut (no evidence of recent collapse)
- **Bed material:** Fine sand/silt, Coarse gravel, Boulders
- **Riparian corridor:** Agricultural Grazing, Moorland
- **Flow condition:** Moderate

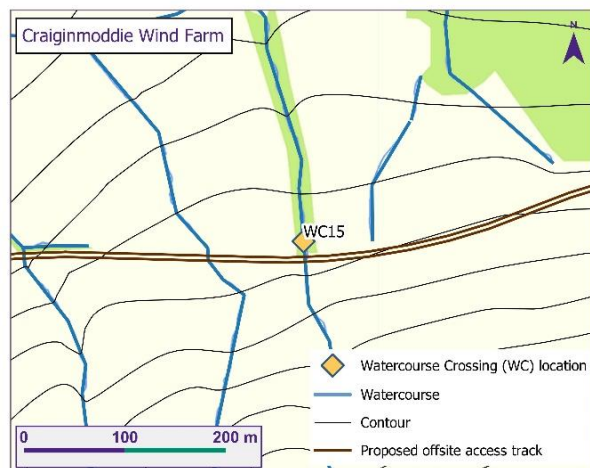
## WC 15 (228176, 600346)

- **Existing Crossing:** No
- **Crossing Type (Recommended):** Bottomless Arch Culvert
- **Channel Type:** Incised
- **Gradient:** Moderate
- **Valley form:** Deep vee
- **Bank condition:** Undercut (no evidence of recent collapse)
- **Bed material:** Fine sand/silt, Rounded pebbles, Coarse gravel, Boulders
- **Riparian corridor:** Heavily Vegetated (e.g. gorse, bramble)
- **Flow condition:** Slow

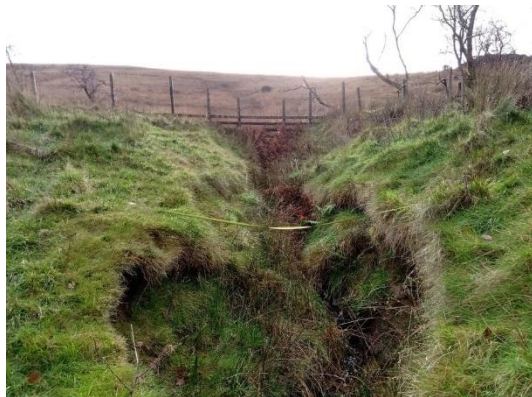
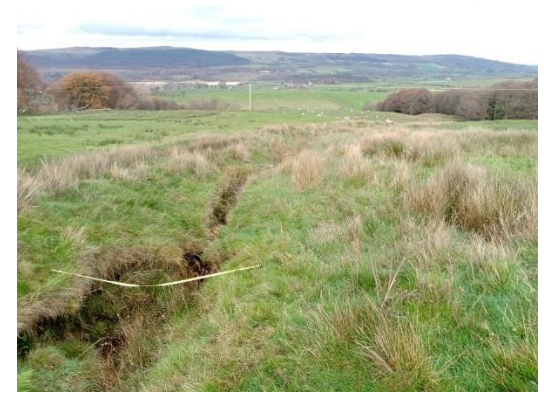
## WC16 (228242, 600358)

- **Existing Crossing:** No
- **Crossing Type (Recommended):** Circular Culvert
- **Channel Type:** Incised
- **Gradient:** Moderate
- **Valley form:** Shallow vee
- **Bank condition:** Unstable (potential recent collapse)
- **Bed material:** Rounded pebbles, Fine sand/silt, Boulders
- **Riparian corridor:** Moorland, Agricultural Grazing
- **Flow condition:** Slow

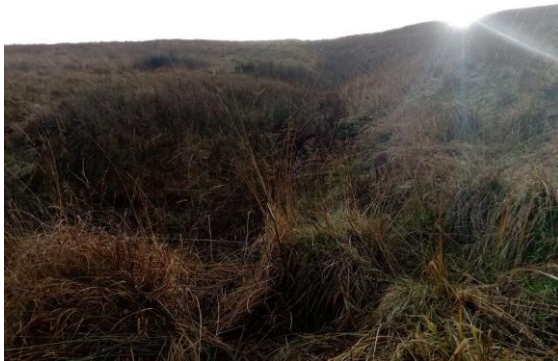
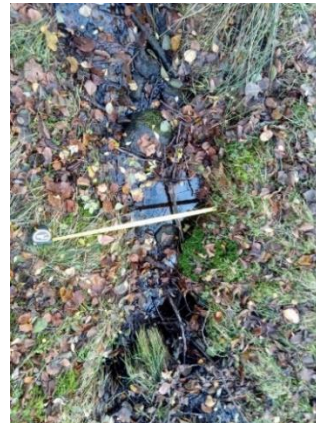
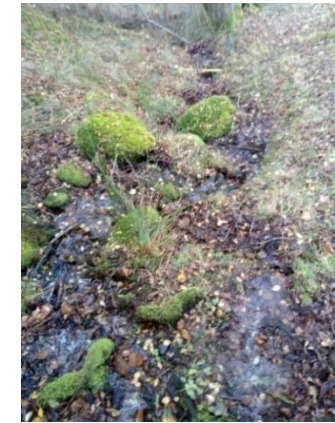
## WC17 (228740, 600432)

- **Existing Crossing:** No
- **Crossing Type (Recommended):** Bottomless Arch Culvert
- **Channel Type:** Surface run-off/wetlands only, Meandering, Poorly defined
- **Gradient:** Steep
- **Valley form:** Shallow vee
- **Bank condition:** Stable
- **Bed material:** Fine sand/silt, Rounded pebbles, Soil, Bedrock
- **Riparian corridor:** Agricultural Grazing, Moorland
- **Flow condition:** Very slow

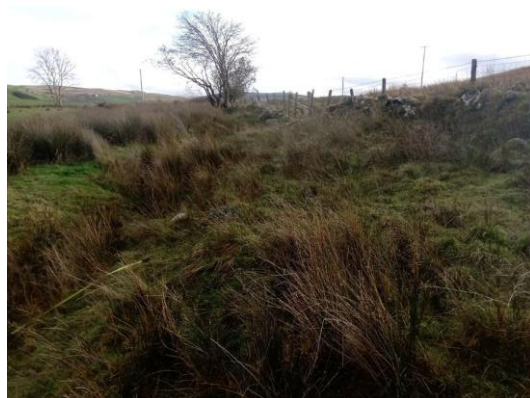
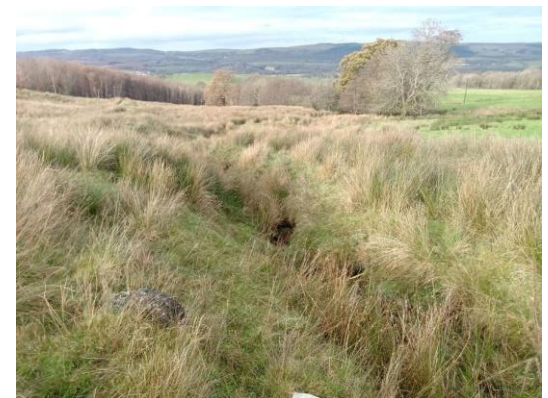
## WC18 (228882, 600441)

- **Existing Crossing:** No
- **Crossing Type (Recommended):** Circular Culvert
- **Channel Type:** Incised, Meandering
- **Gradient:** Steep
- **Valley form:** Shallow vee
- **Bank condition:** Unstable (potential recent collapse)
- **Bed material:** Fine sand/silt, Rounded pebbles, Coarse gravel, Boulders
- **Riparian corridor:** Agricultural Grazing, Heavily Vegetated (e.g. gorse, bramble)
- **Flow condition:** Slow

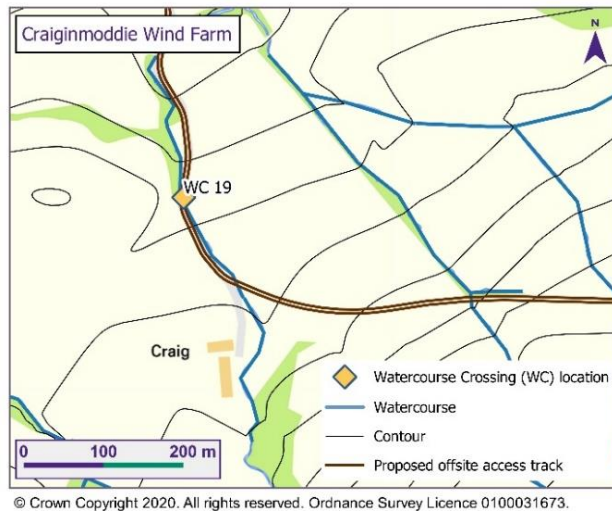
## WC 19 (227539, 600459)

- **Existing Crossing:** Yes (likely upgrade required)
- **Channel Type:** Broad (estimated)
- **Gradient:** Gentle (estimated)
- **Valley form:** U-shape valley (estimated)
- **Bank condition:** Unknown
- **Bed material:** Fine sand/silt, Rounded pebbles, Coarse gravel, Boulders (estimated)
- **Riparian corridor:** Heavily Vegetated (e.g. gorse, bramble) (estimated)
- **Water width (m):** 1.6 (estimated)
- **Water depth (m):** 0.2 (estimated)
- **Bankfull width (m):** 2.0 (estimated)
- **Bankfull height (m):** 0.4 (estimated)
- **Banktop height (m):** 0.6 (estimated)
- **Flooded Bankfull width (m):** 2.9 (estimated)
- **Flooded Bankfull height:** 0.45 (estimated)
