## **Craiginmoddie Wind Farm**

### **Peat Stability Risk Assessment** December 2020

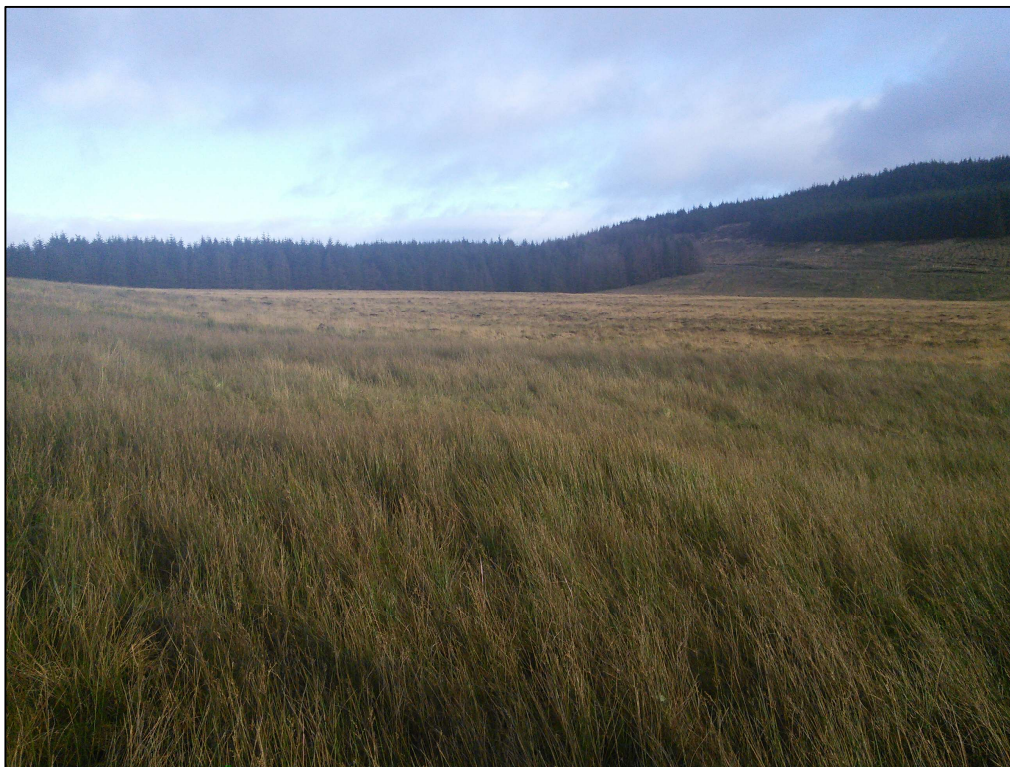
**Photo 1: View north from T8 – Open Ground, recently planted**

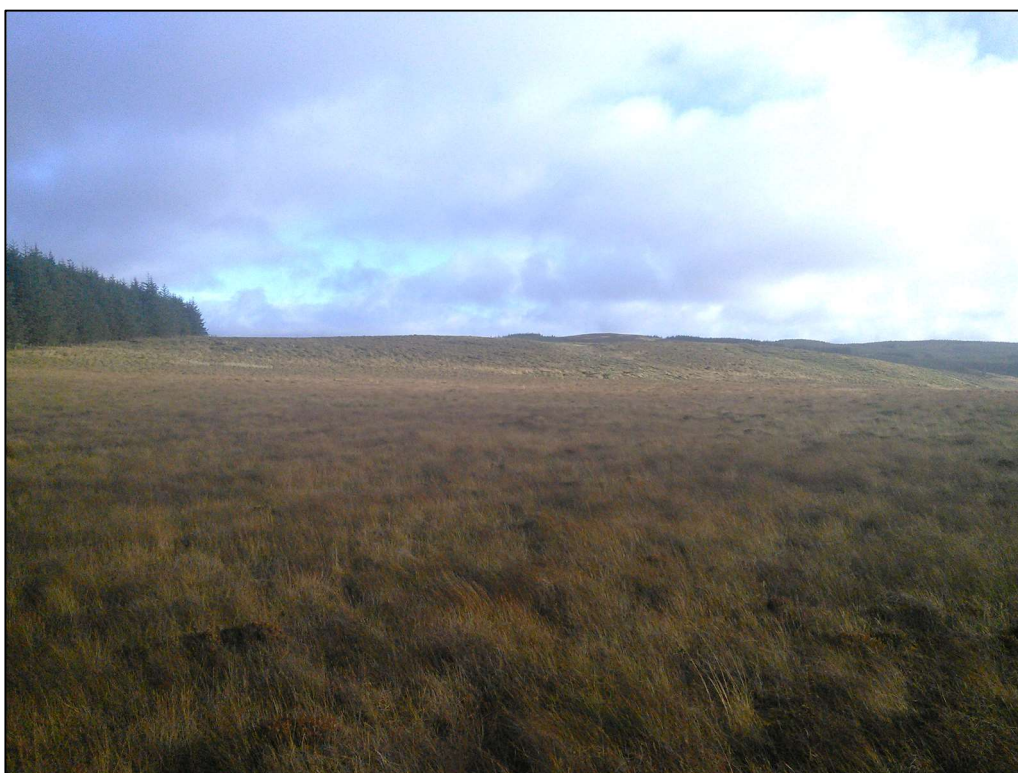
**Photo 2: View north from T9 – Open Ground Raised Bog**

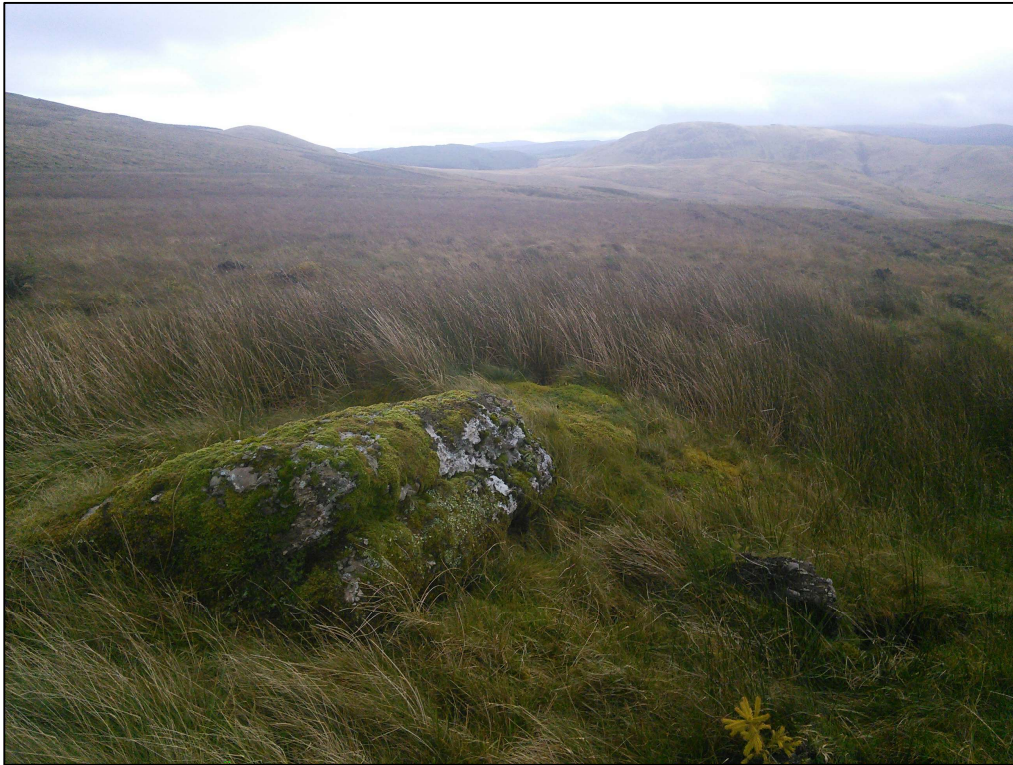
**Photo 3: Borrow Pit Search Area south from T6**

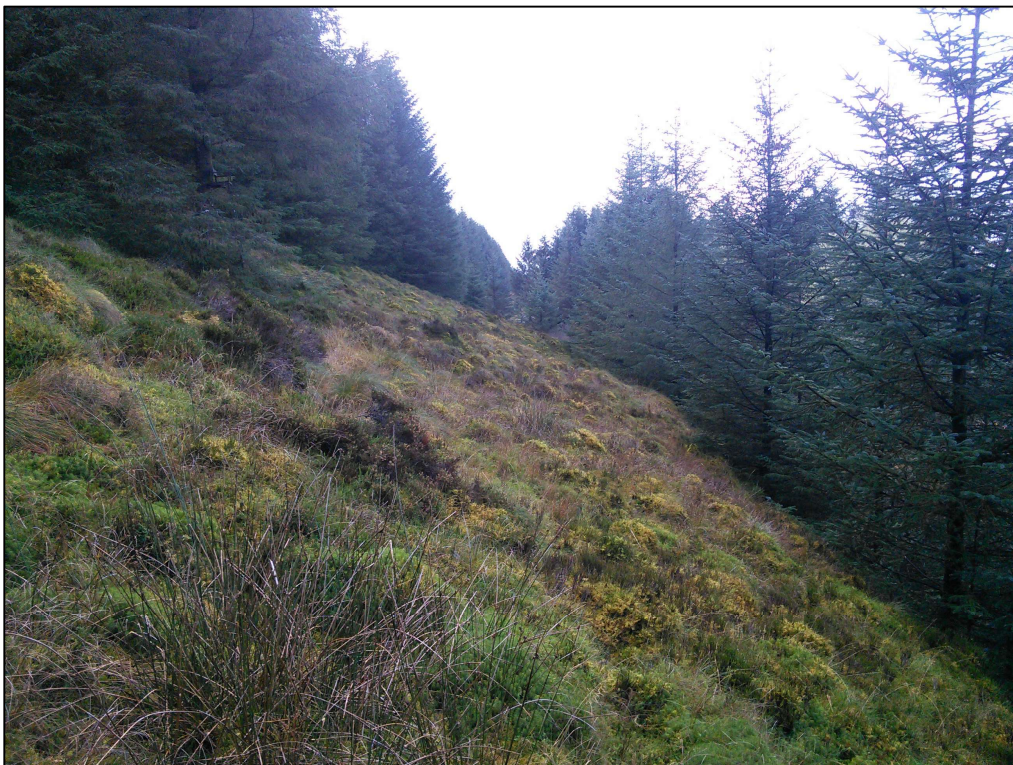
**Photo 4: Forested location at T12 – Thin peat soil on slope system**

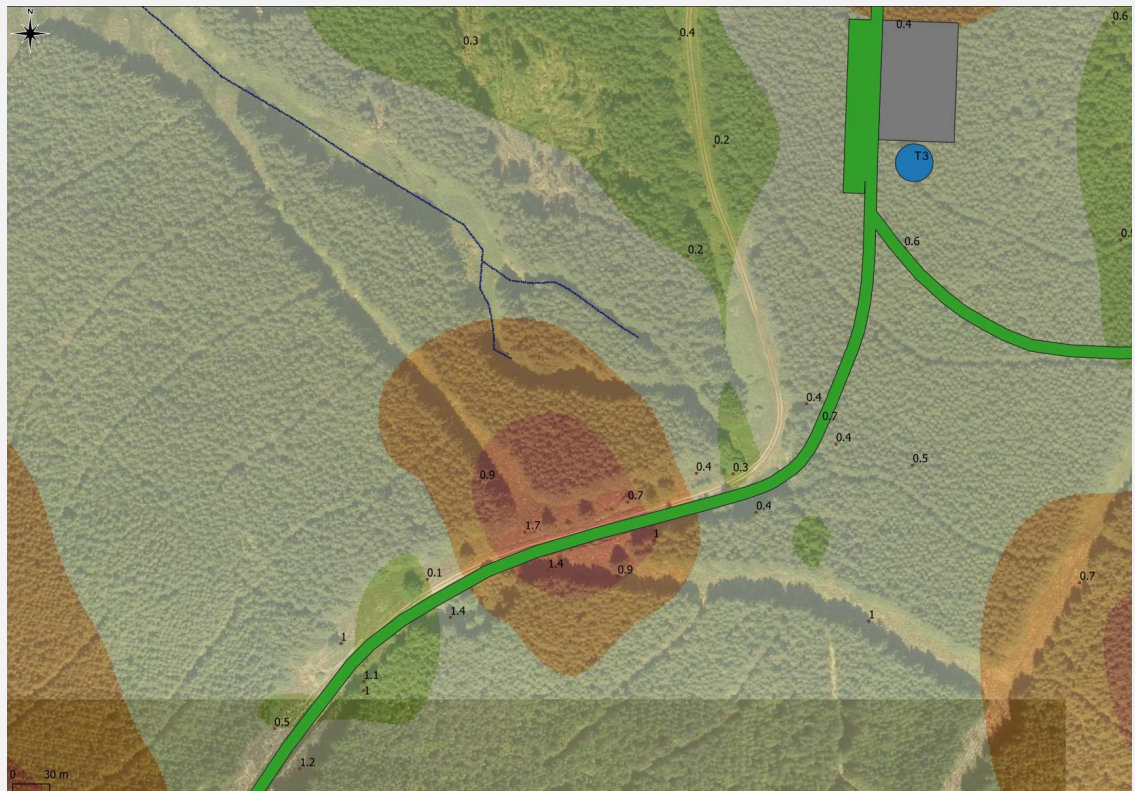
- Proximity to headwaters of tributary watercourse
- Peat depth – up to 1.7m
- Slope angle
- New access track elements will require integration and upgrade of existing infrastructure

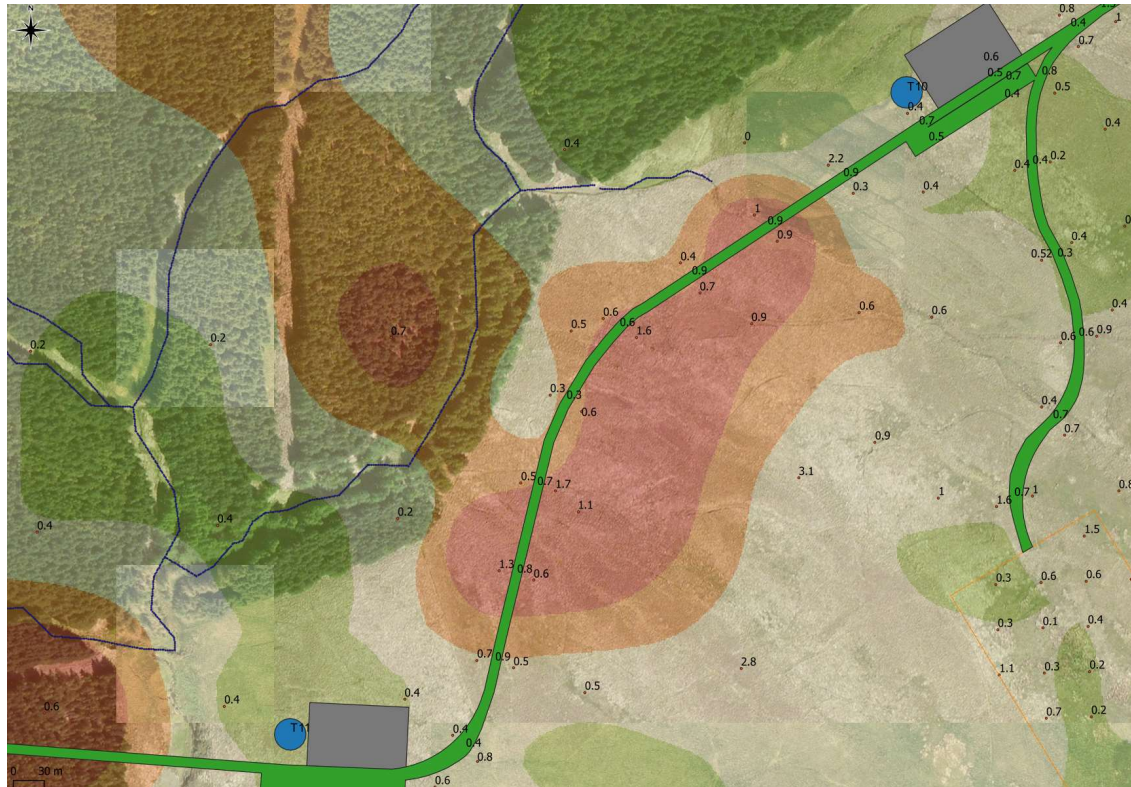
### Track Section – T10 – T11

- Peat depth – up to 1.7m
- Slope angle
- Proximity of main watercourse (down-slope)
